## Cambridge Street Lift Pit

October 2016

**KEY WORKS** – PU Injection and membrane Application

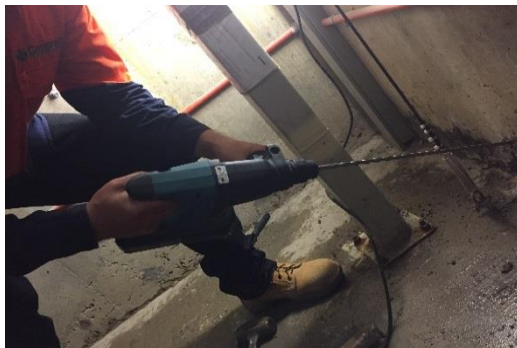
Drilling holes

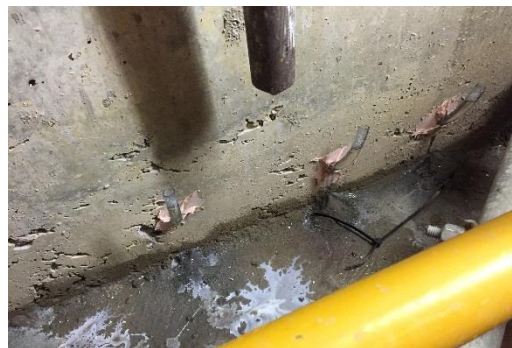
Installing ports

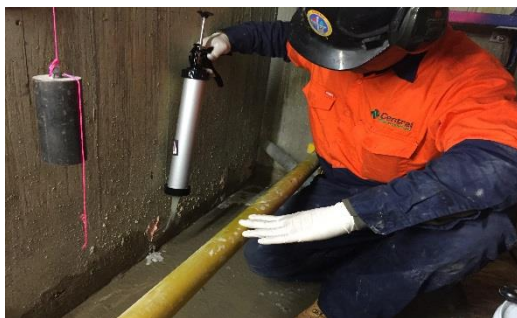
Injecting PU

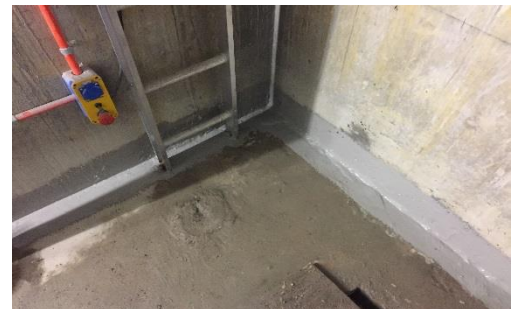
Membrane Applied
