Berwick Concrete Repairs

November 2016

KEY WORKS – Concrete Repair

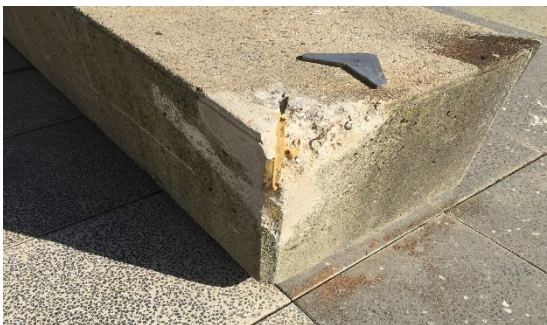
A concrete bench was damaged and repaired by others, but the repair failed.

Old Repair

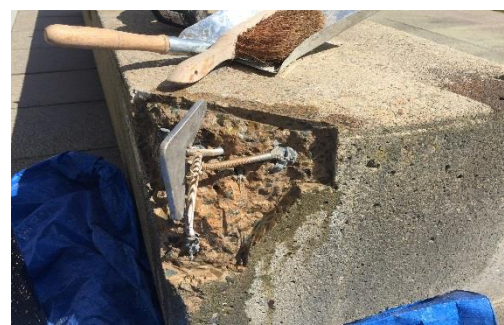
Breakout and steel install

Central Remedial's solution was to break out the old repair, install new steel pins and repair the area using a non-shrink repair mortar.

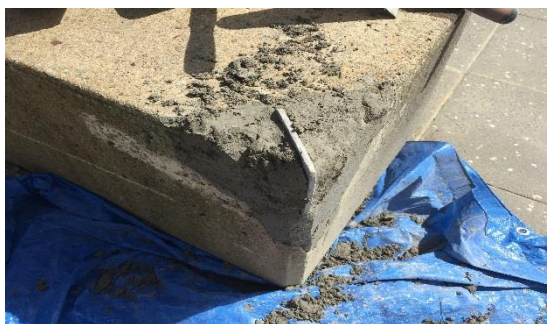
Applying repair mortar

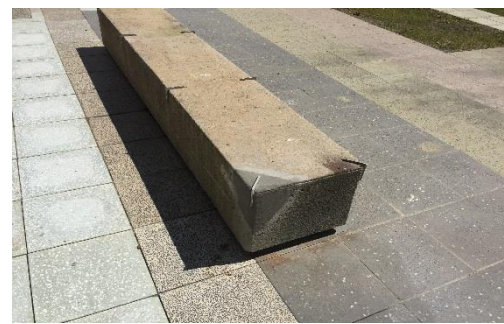
Finished repair
