Pascoe Vale Concrete Repairs

KEY WORKS – Concrete Repair

Repair was needed to spalled areas on concrete beams at a Pascoe Vale church.

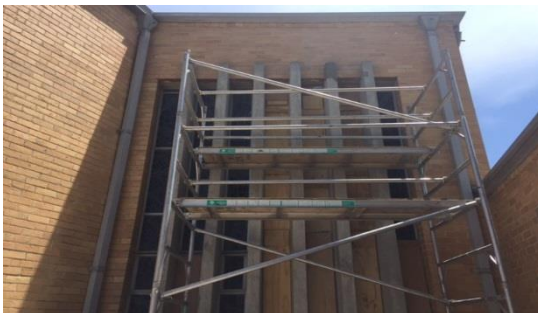
Concrete Beams

Central Remedial's solution was to break out the spalled and damaged concrete, and repair the area using a non-shrink repair mortar.

- Breakout of old repair
- Application of repair mortar

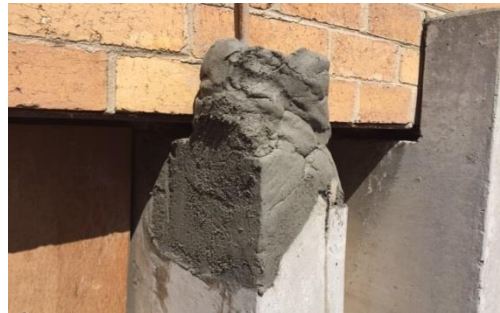
Forming large repair

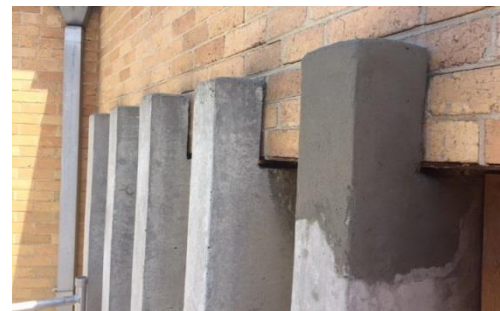
Finishing large repair
