## SHIPLEY STREET JOINTING & WATERPROOFING

OCTOBER 2016

**KEY WORKS** – Waterproofing, Joint Replacement

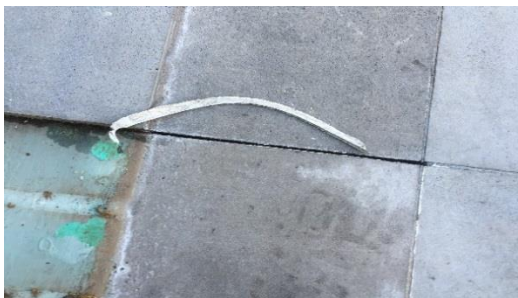
Joint Removal

To rectify the issue, Central remedial removed the existing mastic and grout, taped and primed all joints and sealed the joints with a PU mastic.

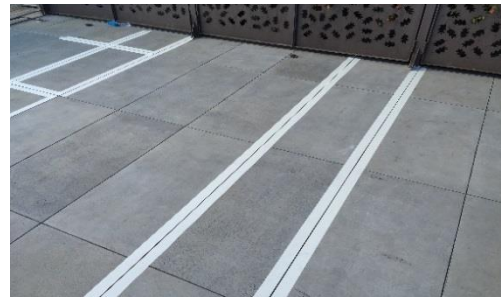
Joint Preparation

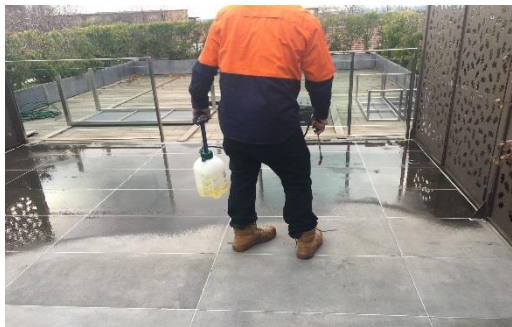
Applying Silane Spray

After the joints were cured, a silane spray was applied to the entire area to further aid the waterproofing detail.

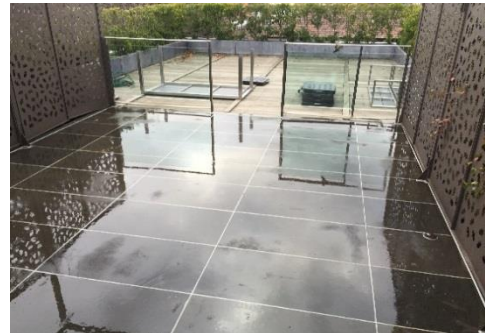
Completed Joints
