## Toorak Road Waterproofing

November 2016

**KEY WORKS** – Waterproofing, PU Injection

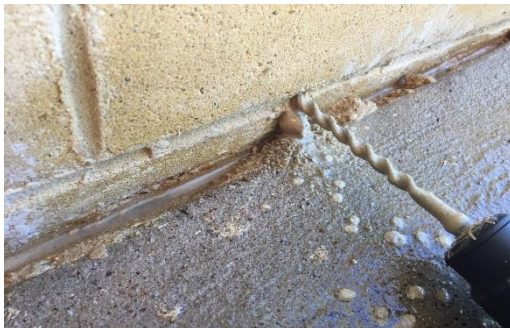
Drilling holes for injection

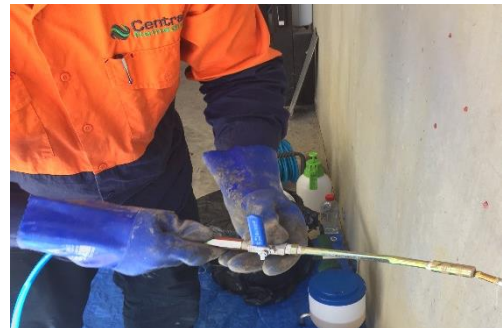
Injecting PU

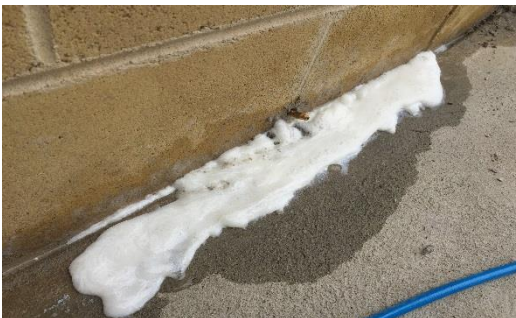
PU reacting with water

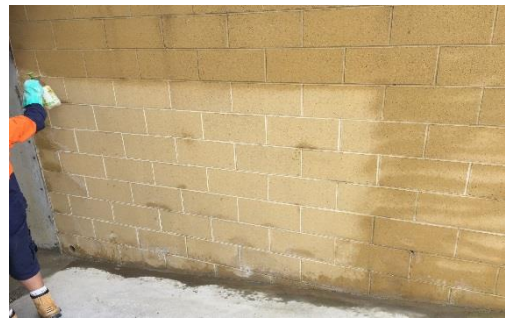
Completed Joints
